The Rambunctious Rim

A workman changing a flat tire on a large earthmover was injured, eventually losing a leg. The manufacturer was then sued. The case history follows the court hearings, providing details and opinions from both sides of the incident, allowing the student to be a member of the jury who decides the outcome.

THE RAMBUNCTIOUS RIM (A)

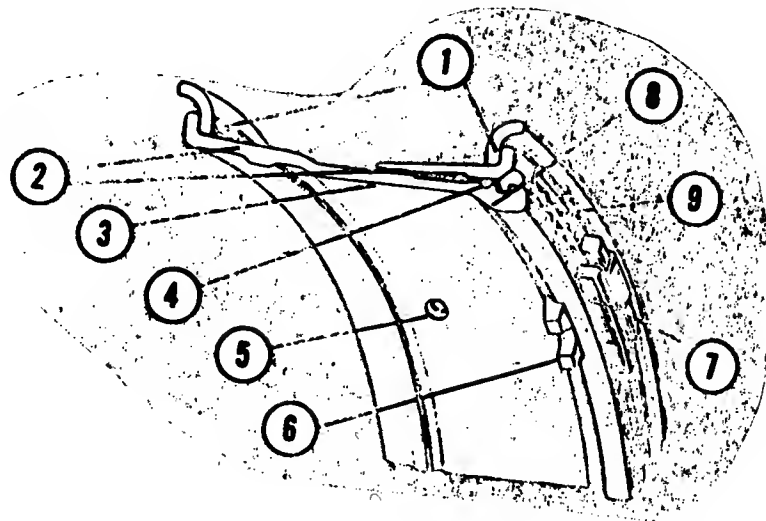
- 1 SIDE FLANGES--two identical cold-formed continuous rings equipped with drivers to prevent circumferential slippage.
- 2 TAPERED BEAD SEATS--full 15° taper supports entire bead of tire--also knurled to further prevent tire slippage.

- 3 RIM BASE--double-weld, submerged arc process joins continuous base sections for maximum strength.
- 4 SEALING RING--famous xxxxxx principle provides positive airtight seal.

- 5 VALVE HOLE--reverse counter bored valve hole located on center line of rim.
- 6 LOCATING LUG--positions valve stem properly and affords valve protection against loose wheel mounting.

- 7 HEAVY DUTY BEAD SEAT BAND DRIVER--prevents circumferential slippage under normal operating conditions.
- 8 STANDARD 28° MOUNTING BEVEL--interchangeable on existing wheels.

- 9 PRY BAR POCKETS-- 180° apart on base and bead seat band--used with hydraulic or hand tools to break tire beads loose from bead seat.

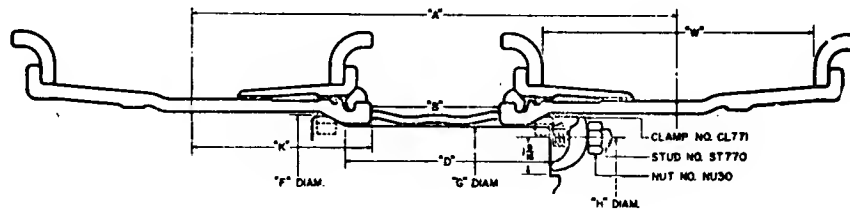
Exhibit A3--Mounting of dual wheels

Two assemblies of the type shown in Exhibit A1 are required. The inboard tire-ring assembly, (left in diagram) is placed so that the mounting bevel bears against a shoulder on the wheel. Note that the lock ring side of the rim base is at the wheel. A spacer ("B" width) is placed between the wheels. The second (outboard) assembly is placed so that its lock ring faces that of the inboard assembly. The stud-clamp-nut combination exerts force against the mounting bevel of the outboard rim base to hold both assemblies in position.
